WHITE'S POND DAM

NH 00106

PHASE I INSPECTION REPORT NATIONAL DAM INSPECTION PROGRAM

AUGUST 1978

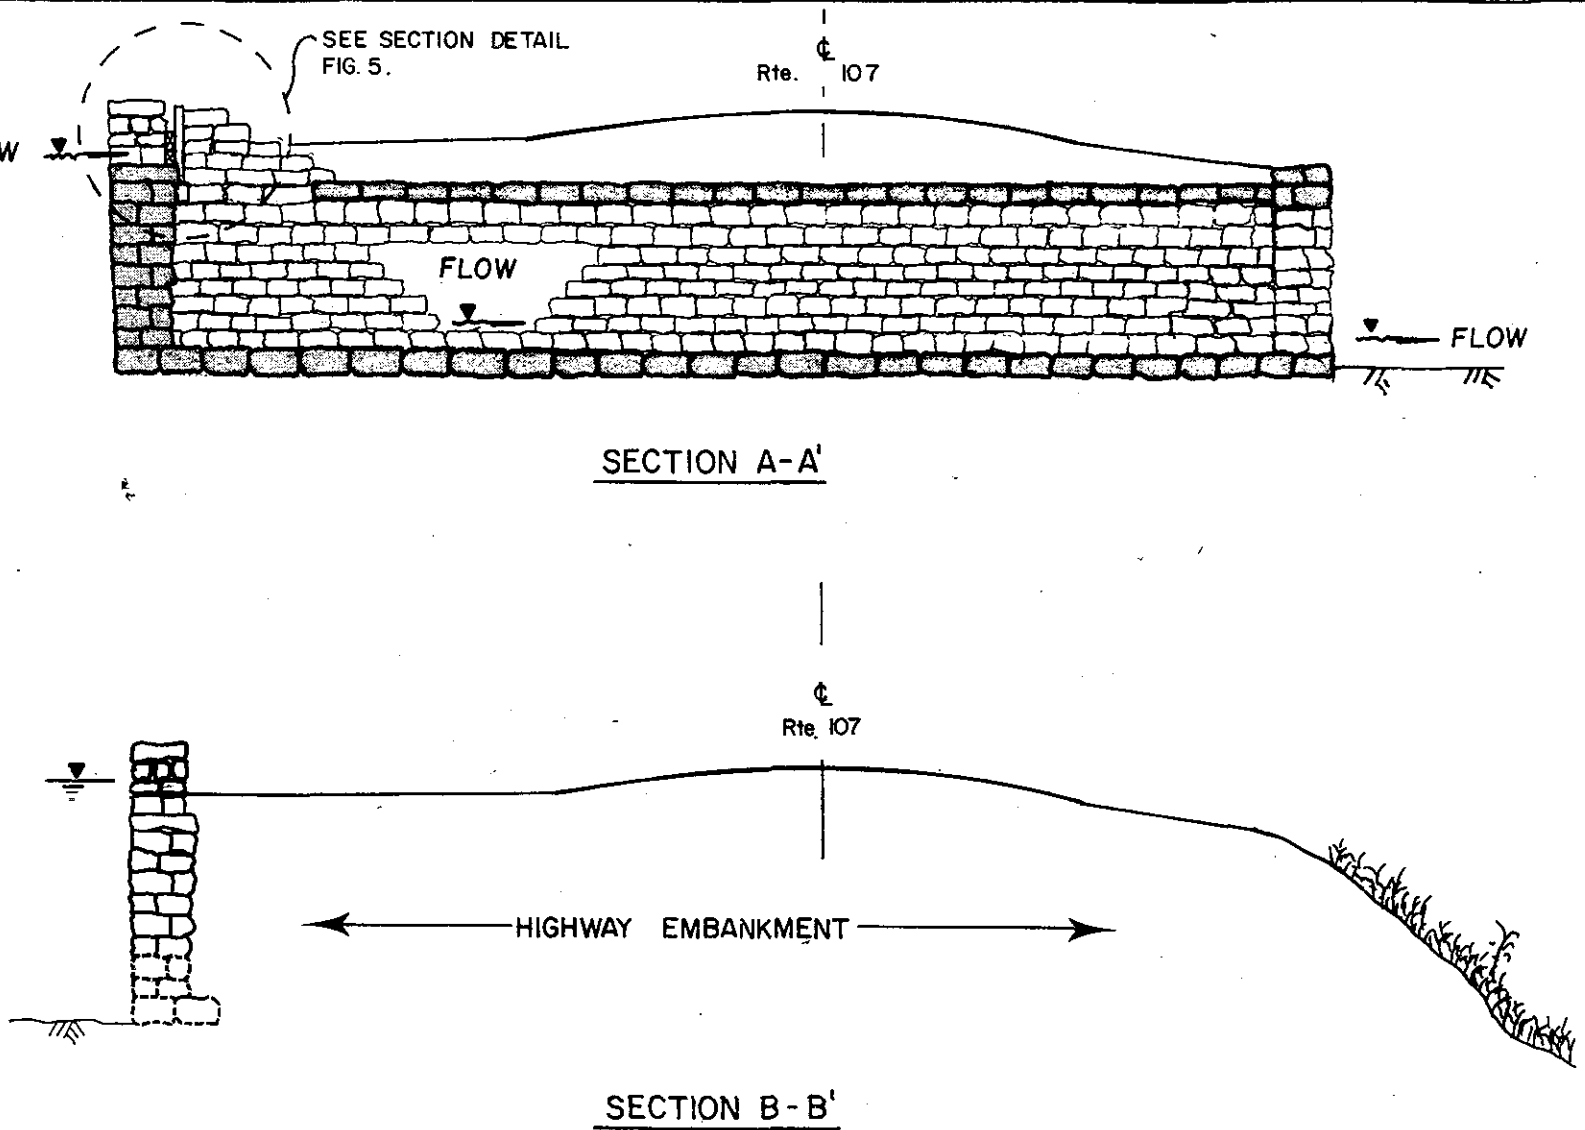
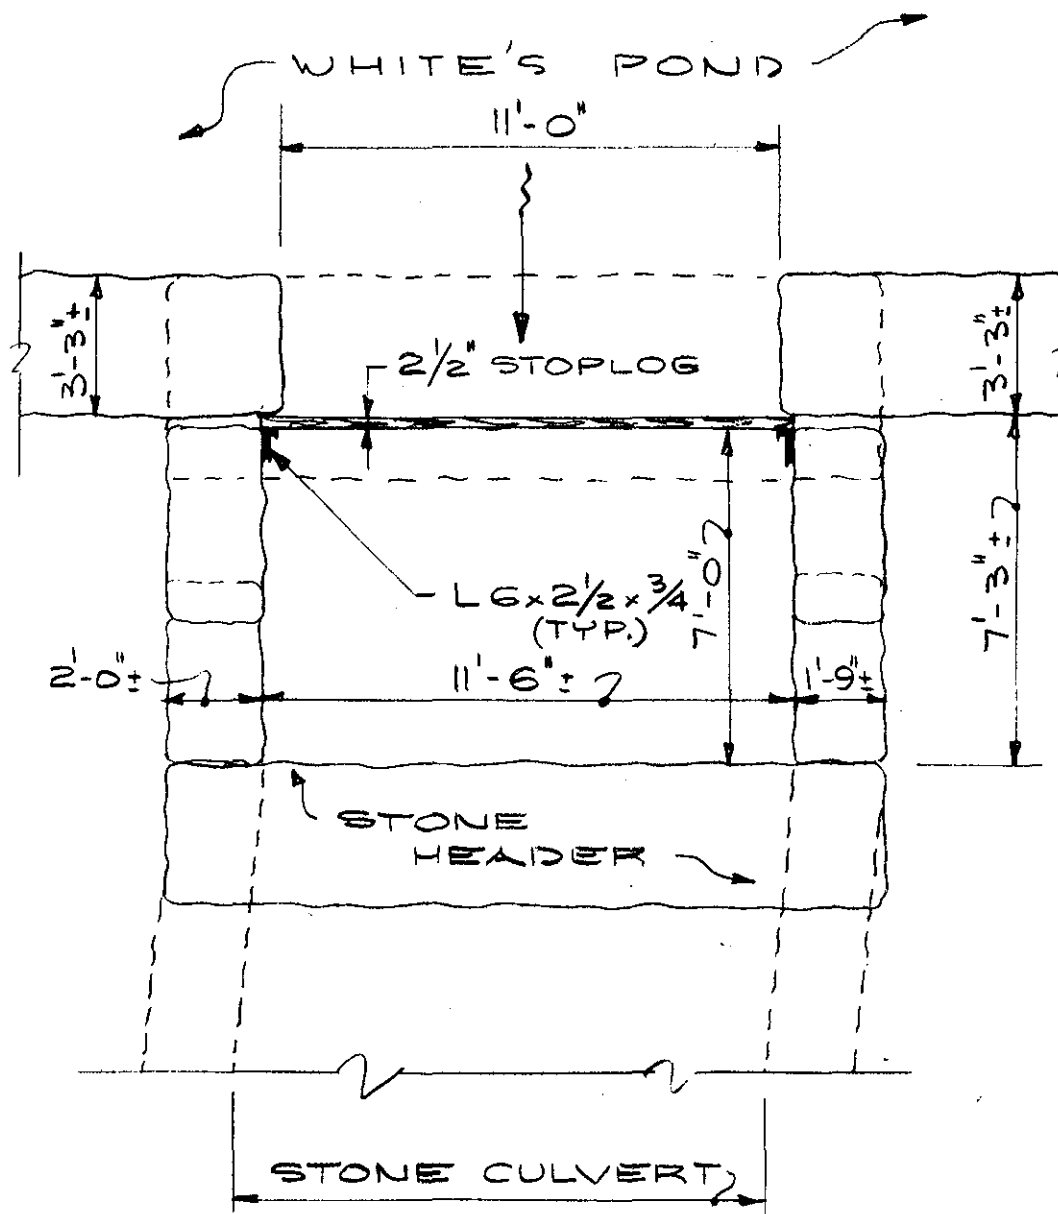
FIG. 4

The spillway structure consists of squared stone granite masonry with unmortared chinking stones (Figures 3, 4, and 5). The spillway is 11.5 feet long by 3.3 feet wide with a 10 foot vertical drop between the spillway sill and the flume invert. A nominal 3 inch by 21 inch timber stop-log is set on top of the spillway and secured by means of restraining angles bolted to the sidewalls of the adjacent flume. The invert of the spillway is 3.7 feet below the top of the granite block facing of the dam. It was observed that continuous seepage is permeating through the second joint coursing of the granite dam facing adjacent to both sides of the spillway; the second capstone joint being below pond level (Photo Nos. 2 and 3).
